## Department of the Navy SBIR/STTR Transition Program

Topic # N161-009 Fastener Attrition Sensing Transducer (FAST) Metis Design Corporation

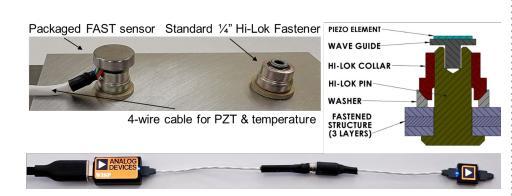
**Notes:** Image illustrates packaged sensor (top left), sensor cross section (top right) and networked acquisition hardware (bottom).

**Technology Developed:** Metis Design Corporation (MDC) had developed a piezoelectric sensor that mounts inside an already-installed Hi-Lok, essentially turning the fasteners into an ultrasonic resonant transducer. Very small changes to the structure caused by flaws near the fastener effectively results in boundary condition differences that can be detected through signal processing. These sensors are compatible with a distributed data acquisition architecture previously developed by MDC, which can be operated as a standalone system or communicate with rotorcraft health and usage monitoring systems (HUMS).
